# Evaluation Report 138

## Sperry New Holland 1033 Automatic Bale Wagon

A Co-operative Program Between

# SPERRY NEW HOLLAND 1033 AUTOMATIC BALE WAGON

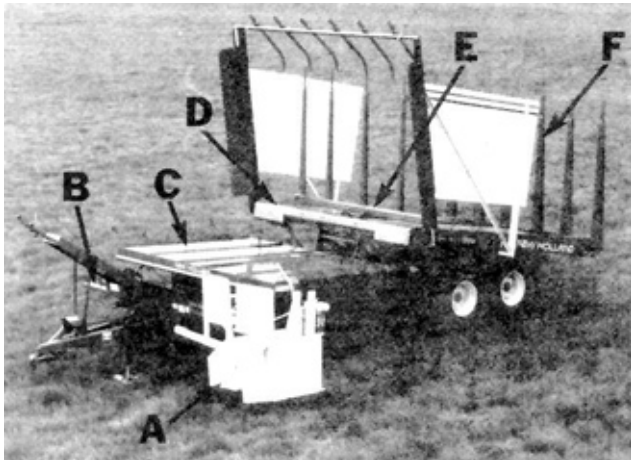
FIGURE 1, New Holland 1033: (A) Loader, (B) First Table, (C) Second Table, (D) Load Deck, (E) Rolling Rack, (F) Load Deck Fingers.

FIGURE 1 shows the location of major components while detailed specifications are given in APPENDIX I.

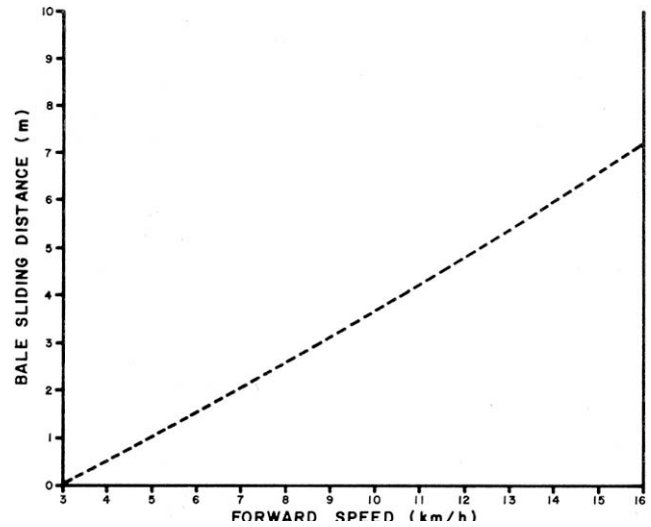
The distance needed to pick a bale off the ground varied with forward speed, bale quality, crop type and field surface conditions. Loader performance was not affected by power take-off speed. At high forward speeds, the bale slid along the ground as it entered the loader, sometimes causing broken twines or bale damage. FIGURE 2 shows the sliding distance when picking 25 kg, 1040 mm long wheat straw bales, over a range of ground speeds. No sliding occurred at speeds below 3 km/h, while at 10 km/h, the bale had to slide 3.5 m as it entered the loader.

FIGURE 2. Bale Sliding Distance over a Range of Ground Speeds, when Picking Wheat Straw Bales.

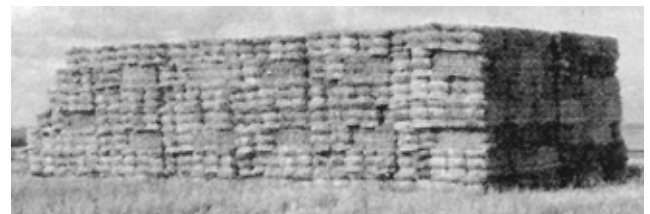
**Stack Quality:** Stack quality and durability depended on operator care, operator experience, bale quality, bale uniformity and selection of a suitable stack site. With proper care in baler operation, site selection and unloading, solid, durable stacks (FIGURE 3) were formed. If bales were of poor or variable quality, or if care was not taken in selecting a good stack site and in properly positioning bale loads within the stack, the stack usually collapsed within several days (FIGURE 4).

FIGURE 3. Solid, Durable Stacks were Formed when Proper Care was Taken in Baler Operation, Site Selection and Unloading.

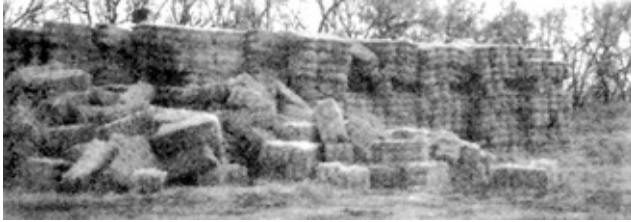
FIGURE 4. Poor Site Selection, Poor Bale Quality, or Careless Unloading Usually Resulted in Stack Collapse.

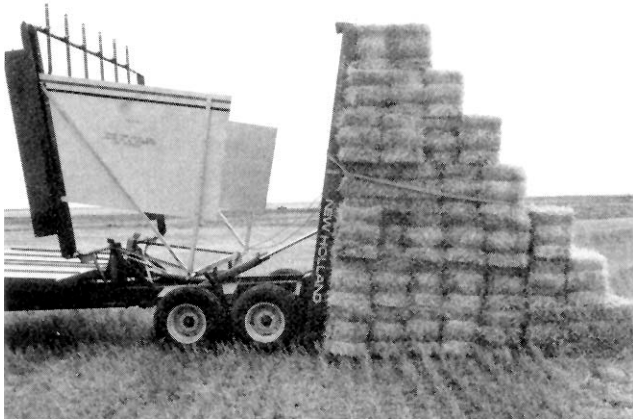
An adequate backstop was needed to start a stack. Full loads, which were rearranged by hand, as shown in FIGURE 5, formed a good backstop. Placing a full load against a fence, or placing props against the first load, usually was inadequate and lead to stack collapse. Partial loads from field cleanup had to be unloaded by hand and could sometimes be used to finish a stack and stabilize its end.

FIGURE 5. Suitable Backstop Formed by Rearranging a Full Load by Hand.

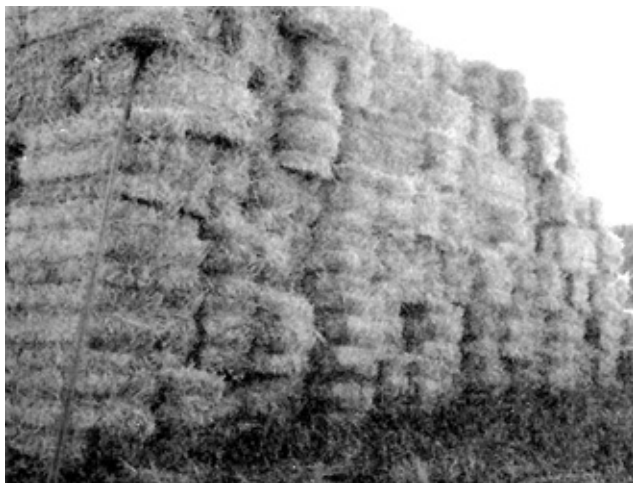
Good quality, durable stacks required dense, well-formed, uniform bales. Stack durability was greatly influenced by baler performance. Poorly formed bales on the bottom, usually settled, resulting in collapse. Non-uniform bale lengths resulted in reduced stability and unsightly appearance on the right stack side, since all the bale length variations accumulated on this side (FIGURE 6).

FIGURE 6. Non-Uniform Right Stack Side Resulting from Bale Length Variations.

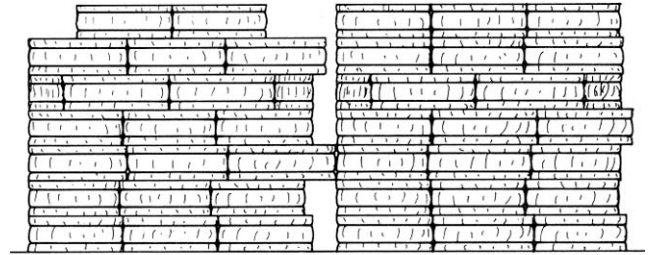
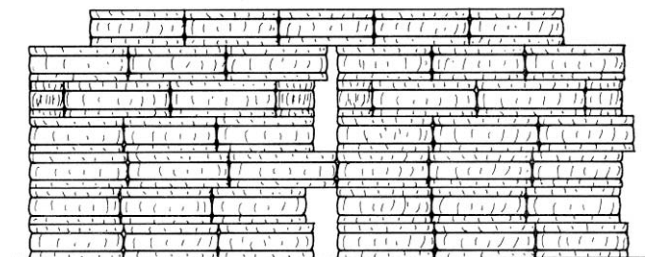
leading to internal weathering and spoilage. When gaps were a problem, the stack could be hand capped by moving the top bales as shown in FIGURE 7. For single row stacking, the stack could be automatically capped, with two bales, by using the tier mechanism on the last load tier.

FIGURE 7. Hand Capping to Reduce Weathering Between Bale Rows.

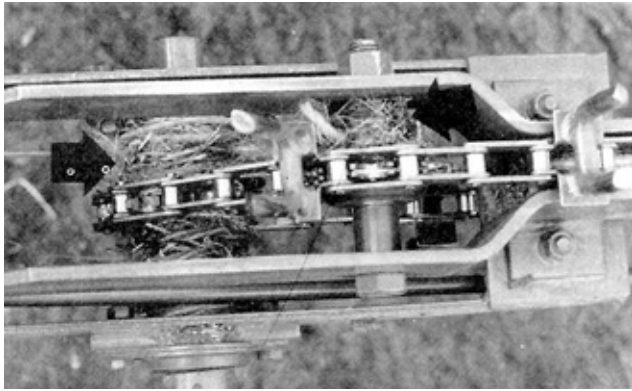
The twine from broken or deformed bales became entangled in the loader and cross conveyor chain sprockets. Twine buildup caused the chains to jam and stop (FIGURE 8) on several occasions.

FIGURE 8. Twine Build-up on Loader and Cross Conveyor Drive Sprockets.

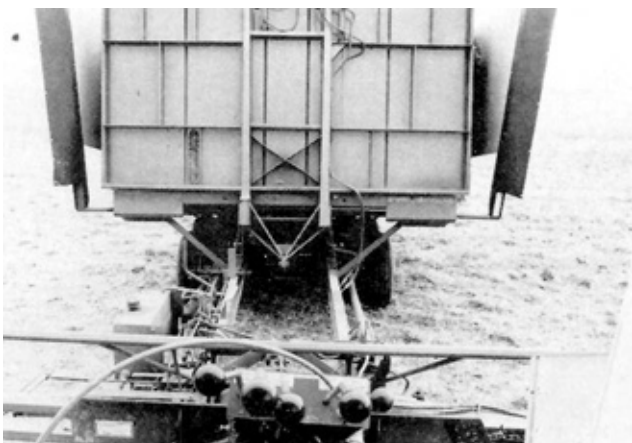
**Stacking:** Unloading the New Holland 1033 was easy once the wagon had been aligned with the stack. A skilled operator had little difficulty backing squarely into the stack. Visibility was limited (FIGURE 9). Aligning the wheels with previous tracks or markers aided in load alignment.

FIGURE 9. Limited Visibility when Backing into the Stack.
